Phase 3.9-3.11 Allotments  
Zuccoli, City of Palmerston

# LEVEL 1 REPORT

BMD Urban

Job No. DAR2025 – 0081 | Version 0

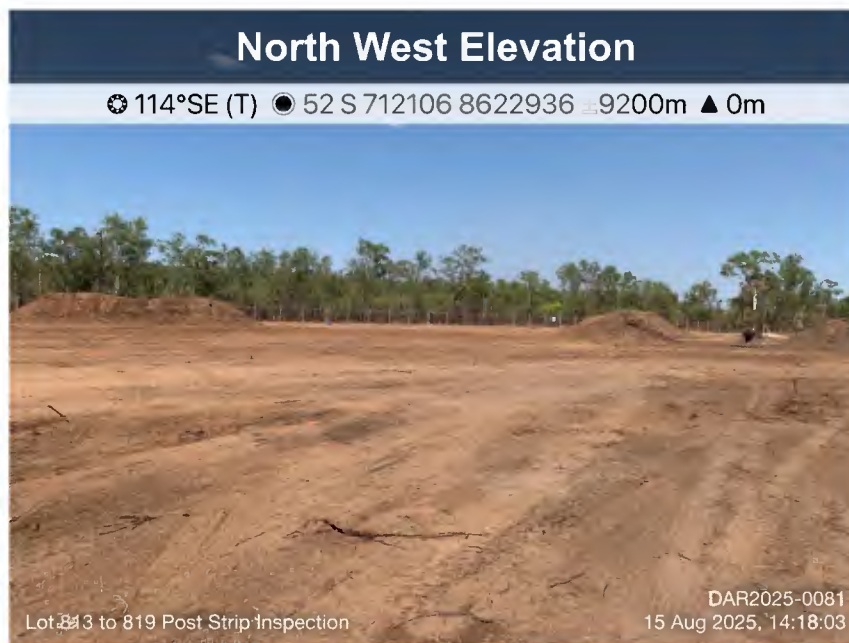
Figure 3: Minor Surficial Roots and Organics

CMW carried out a thorough post-strip inspection of the designated areas over multiple days and confirmed that all topsoil had been completely stripped. Following the inspection, CMW expressed satisfaction with the condition of the areas inspected, noting that they met the required standards. An example of roots directed for removal can be seen in **Figure 3** below.

This was followed by approval of the exposed surface by a Geotechnical Engineer, based on proof rolling and visual inspection (refer Section 2.3), following a nominal stripping depth of approximately 150 mm, with some areas requiring deeper treatment due to extensive roots.

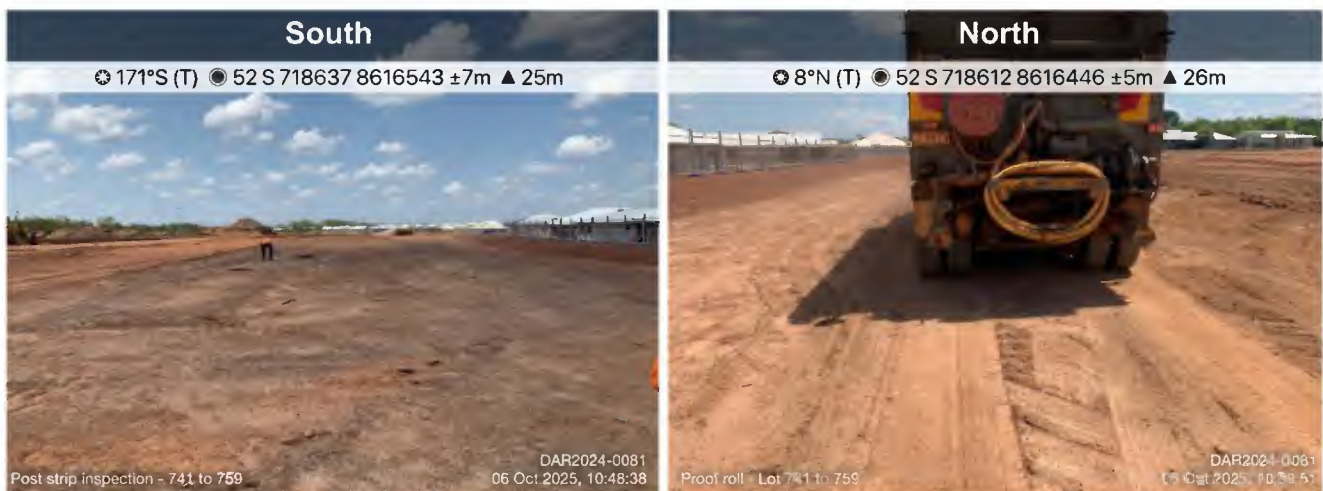
Figure 7: Post Strip area (left) followed by proof roll inspection

Proof rolling was undertaken on the subgrade, supervised by the inspecting Geotechnical Engineer. Proof rolling of the subgrade and subsequent layers was visually assessed while tracked with a fully laden water cart. Proof rolling was undertaken over multiple days as works progressed from the southern lots, as noted above. The allotments were deemed satisfactory where no visible deflection was observed during proof rolling. Proof rolling was deemed satisfactory when no visible deflection was observed over the entire area proof rolled. **Figure 7** below shows typical site conditions observed during post-strip proof roll inspection of a section of an allotment.

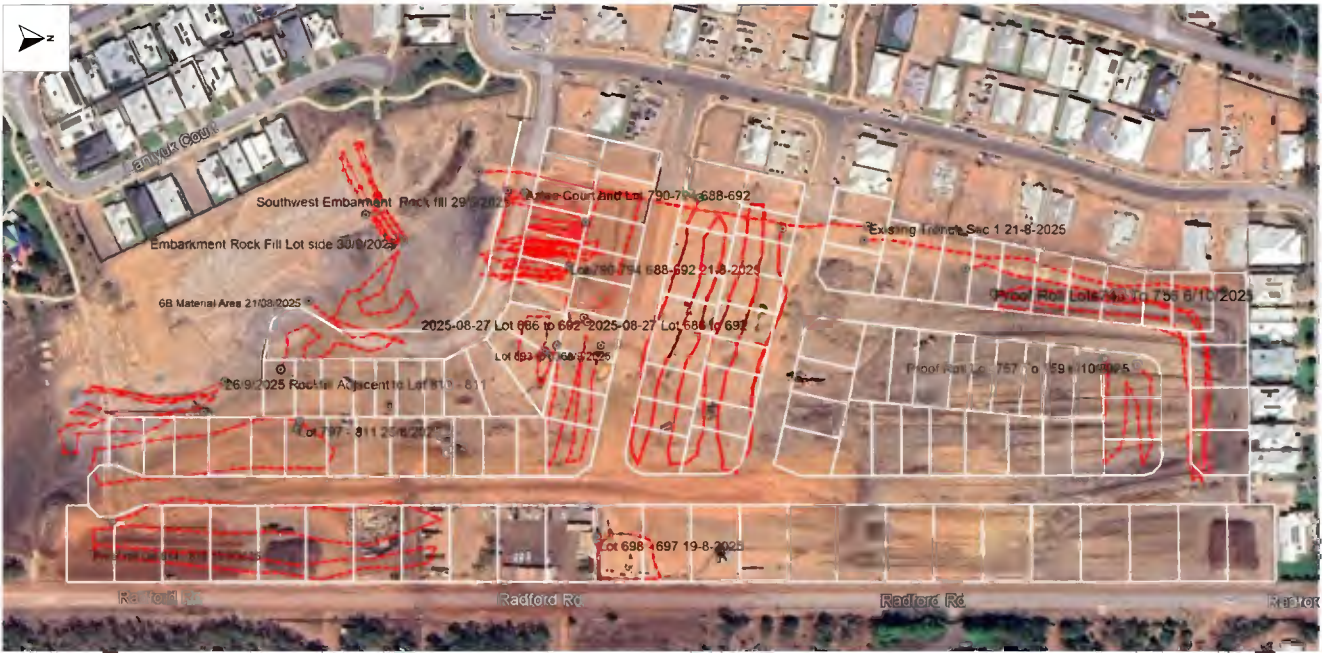
Figure 8: Proof Rolling (dotted red lines)

Proof rolling was undertaken on the prepared foundation over multiple days once areas were ready. **Figure 8** outlines the proof rolling undertaken across the site (not exhaustive, some areas were not recorded however were still proof rolled). Proof rolling was considered to pass in all lot areas subject to inspection.

Final proof rolling was assessed with rollers on the surface of the Level 1 placed fill for each lot at completion, with at least a single pass of the entire area undertaken. No deflection was observed, and the surface was deemed suitable for the subsequent filling works.

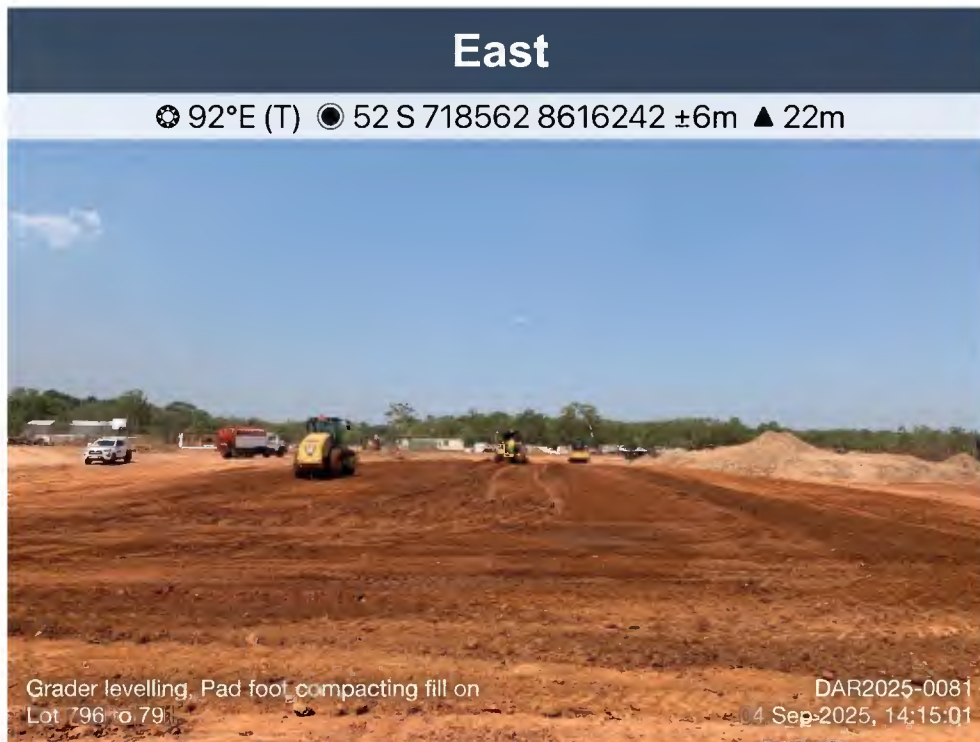
Figure 12: Level 1 site works – Typical Conditions

Photographic records were taken for every site visit, inspection, proof roll and sampling point for internal records. Photo locations are provided in **Appendix A**. **Figure 12** presents typical site works and ground conditions observed during level 1 supervision, with daily inspection records included in **Appendix B**.

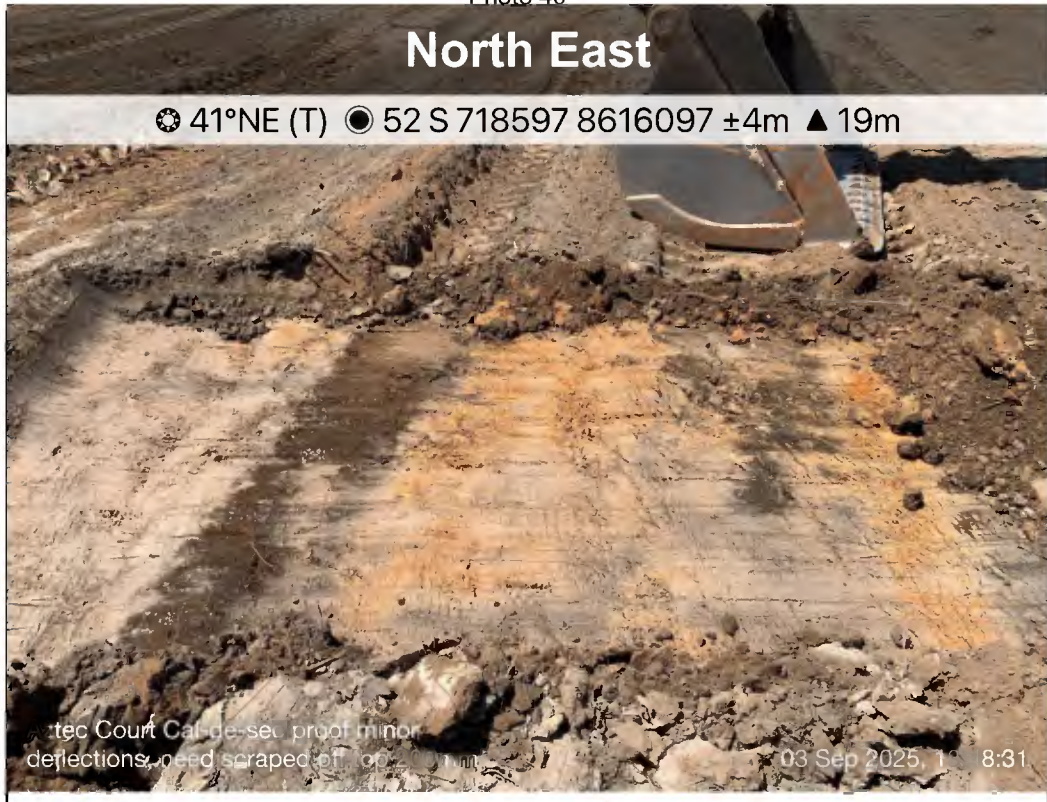
tec Court Cal-de-sac proof minor  
deflections, need scraped off top

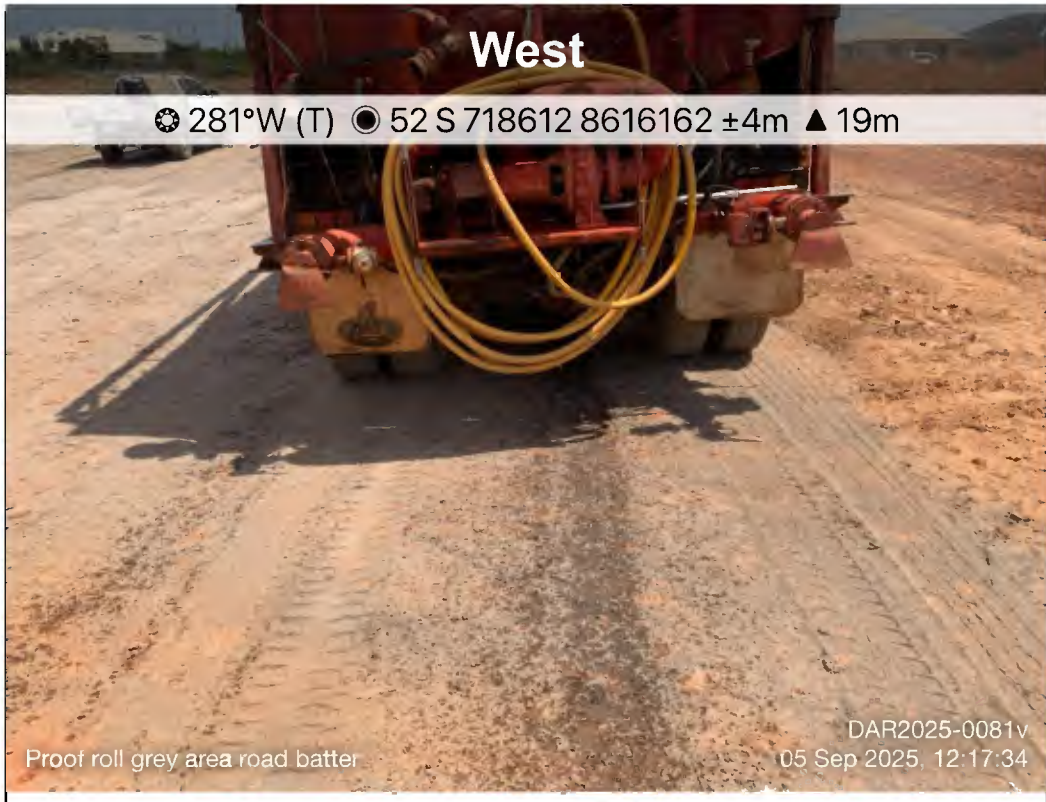
Proof roll grey area road batter

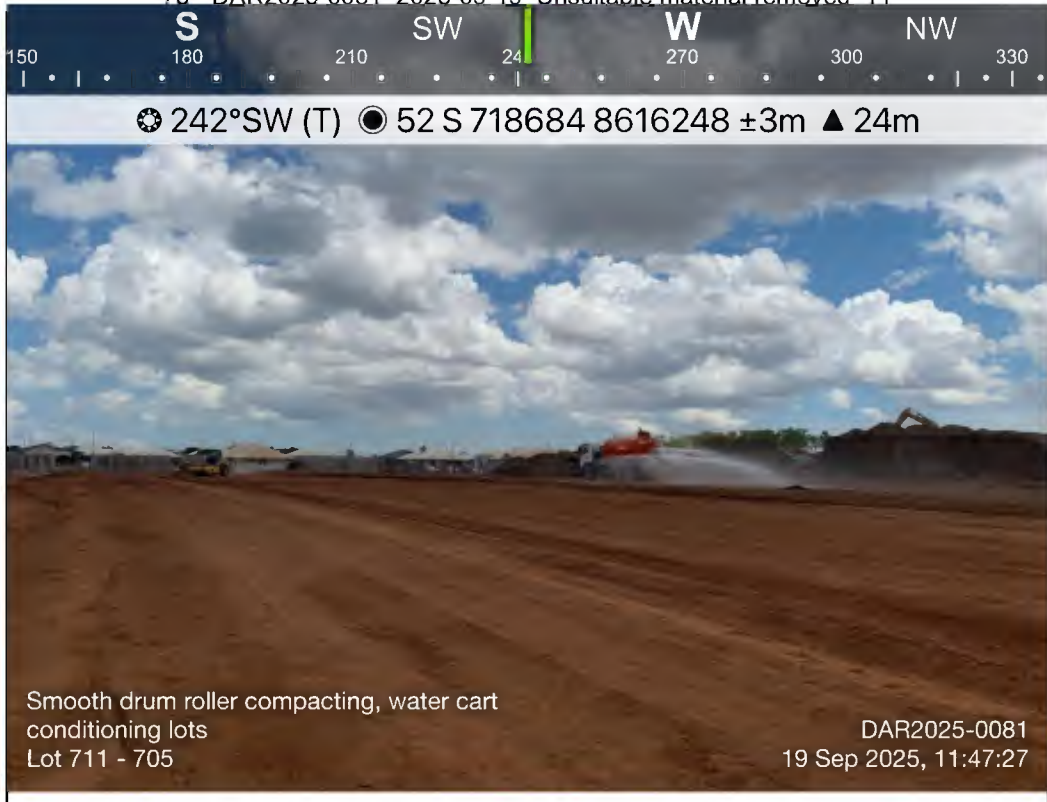
Photo 74 - DAR2025-0081\_2025-09-19\_Smooth drum roller compacting, water cart conditioning lots\_11-47-27

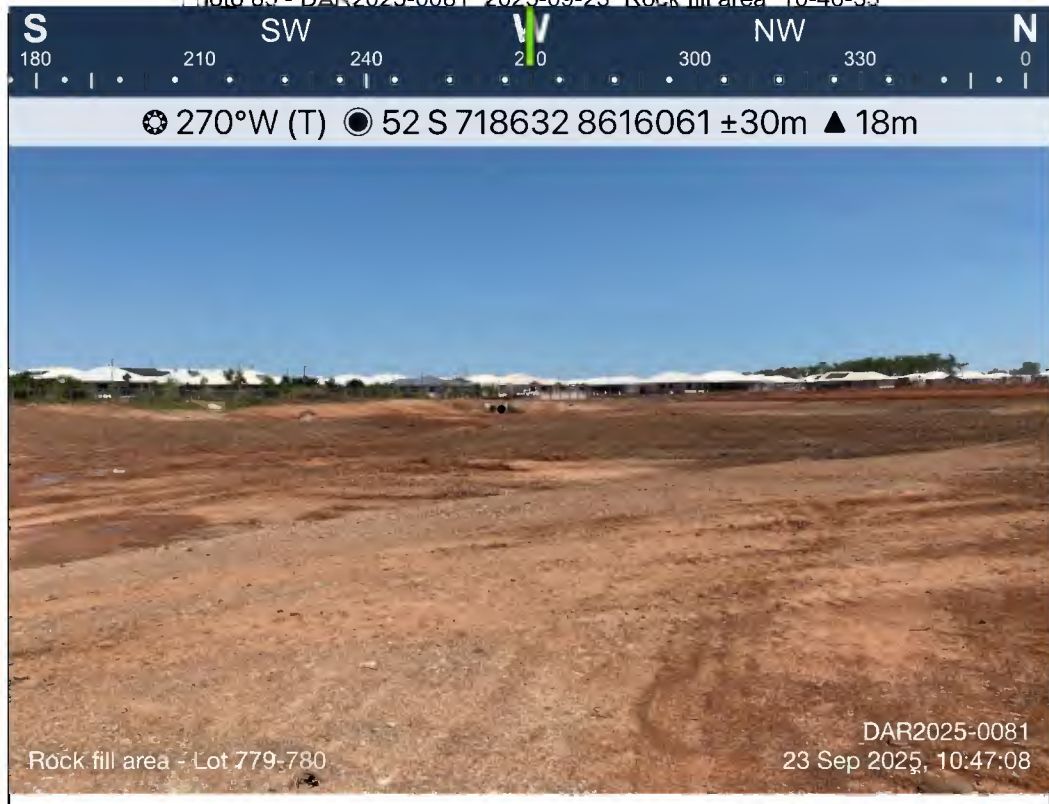
Dilush Anthonige	10/09/2025	Earthworks	<p>Works continued Lots 688 to 695.</p> <p>Rockfill areas adjacent to Lots 810 to 811 were inspected. In the rockfill area adjacent to Lots 779 to 780, a significant amount of oversize material was observed; therefore, acceptance will rely on proof rolling, as laboratory density testing is not suitable due to the oversized particles. A sample was taken from the crushed rock stockpile for quality testing. On site in cut material was sampled for testing.</p>	1 x Grader 1 x Scraper 1 x Pad foot 1 x Water cart
Dilush Anthonige	11/09/2025	Earthworks	<p>Fill placement continued Lots 688 to 695 (LY3), with testing conducted on Layers 1, 2, and 3. Crushed concrete was placed on the road batters along Aztec Court from the western end past the cul-de-sac to the southern section. Material was being carted to</p>	1 x Grader 1 x Pad foot 1 x Water cart

Photo 86 - DAR2025-0081\_2025-09-23\_Rock fill area - Lot 779-780\_10-47-08
